31-POINT PREVENTATIVE MAINTENANCE CHECKLIST

SITE ADDRESS	PERTH, WA	DATE	01/01/2021
TECHNICIAN	Tim Iten	GATE TYPE	SINGLE SWING GATE
CONTROL BOARD & MOTOR VOLTAGE		240V SUPPLY – 12 – 24v motors

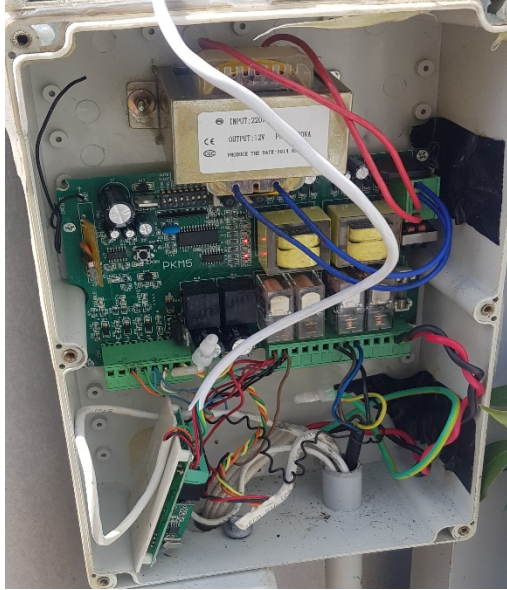
<p>IMAGE 1</p>

<p>Comments (optional)</p>	<p>RELAYS NOT FIRING EVERYTIME WHEN ACTIVATED BY REMOTE – AGE ISSUE. CONTROL BOARD SEALED WITH SILICON.</p>	
<p>IMAGE 2</p>

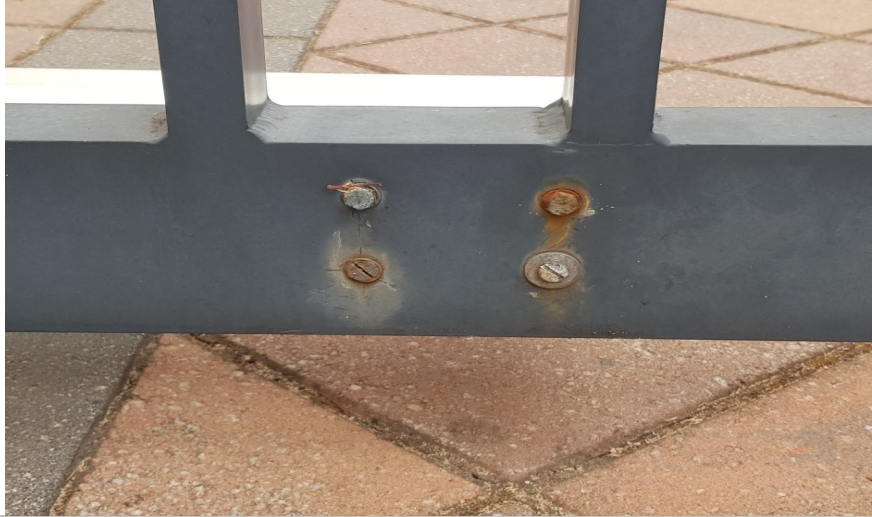
Bolts & Fixings	x	x	Retightened all as required.
Motor Brackets	x	x	Retightened front pick up bolts, starting to rust out as incorrect bolts were used during original installation. Refer to Image 2.
Locks		x	Lock cover held on by tape, requires attention. Looks like impact damage by vehicle. Refer to image 3 below.
Gate Track		n/a	
Gear Rack		n/a	
Guide Rollers		n/a	
Gate Wheels		n/a	
Lubrication	x	x	All moving parts as required, WD40 & Grease.
COMPLETED / SIGNED			
EXTRA COMMENTS	<p>Some Owners/tenants reported, the gate has an intermittent fault, gate not opening every time in the mornings, takes a couple goes for it to open.</p> <p>After some testing and fault finding, technician advised there is no obvious issue, this could be a result of age of the control board, the relays sticking and not firing when remote signal received. Control board is still the original, so it is due for an upgrade.</p> <p>New control board Budget \$375.00 + GST</p> <p>Issue with Lock cover being damaged by vehicle impact, this needs to be replaced, Budget \$250.00 + GST.</p> <p>Front motor brackets rusty bolts need replacement; they will snap which can cause potential motor gear box damage if used.</p> <p>Budget 4 Galv bolts \$10.00 + GST.</p> <p>Control box showing signs of seal not in tac, silicon is used to seal top of control box.</p> <p>Control box replacement budget \$200.00 + GST.</p> <p>Labour – \$300.00 + GST</p>

<p>Comments (optional)</p>	<p>Rusty bolts, require replacement in the near future.</p>	
<p>IMAGE 3</p>

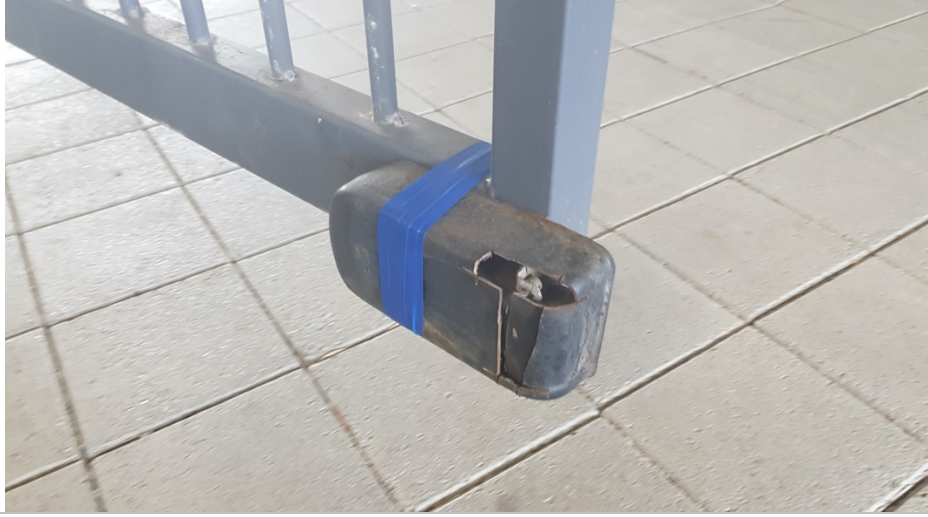
<p>Comments (optional)</p>	<p>Electrical tape used to secure damaged component; lock cover requires replacing.</p>
